Before the Auckland Unitary Plan Independent Hearings Panel

**SUPPLEMENTARY EVIDENCE OF JAMES DAHM
ON BEHALF OF KARAKA HARBOURSIDE ESTATE LIMITED
(SUBMITTER 3644; FS 2965)**

RE PARAREKAU ISLAND

DATED 11 January 2016

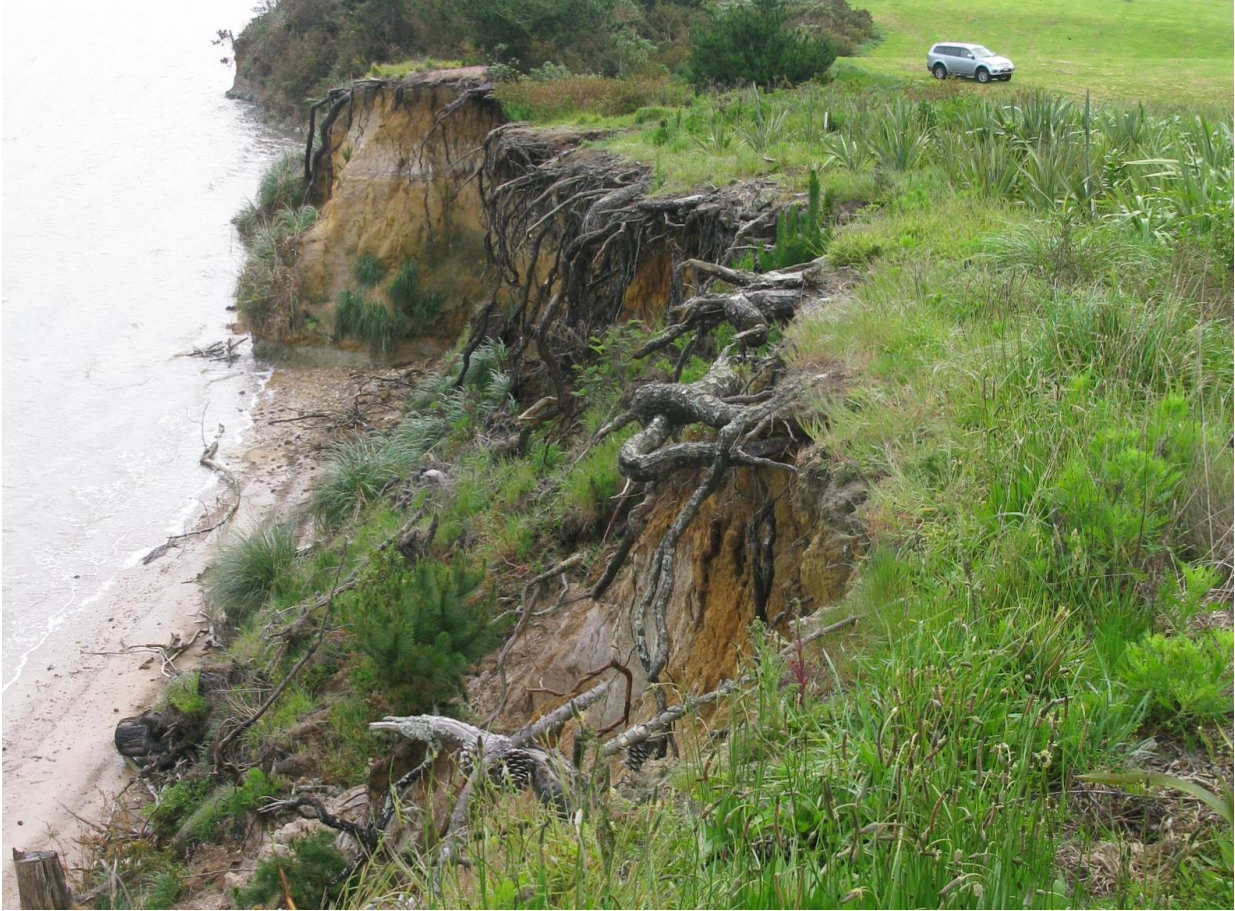
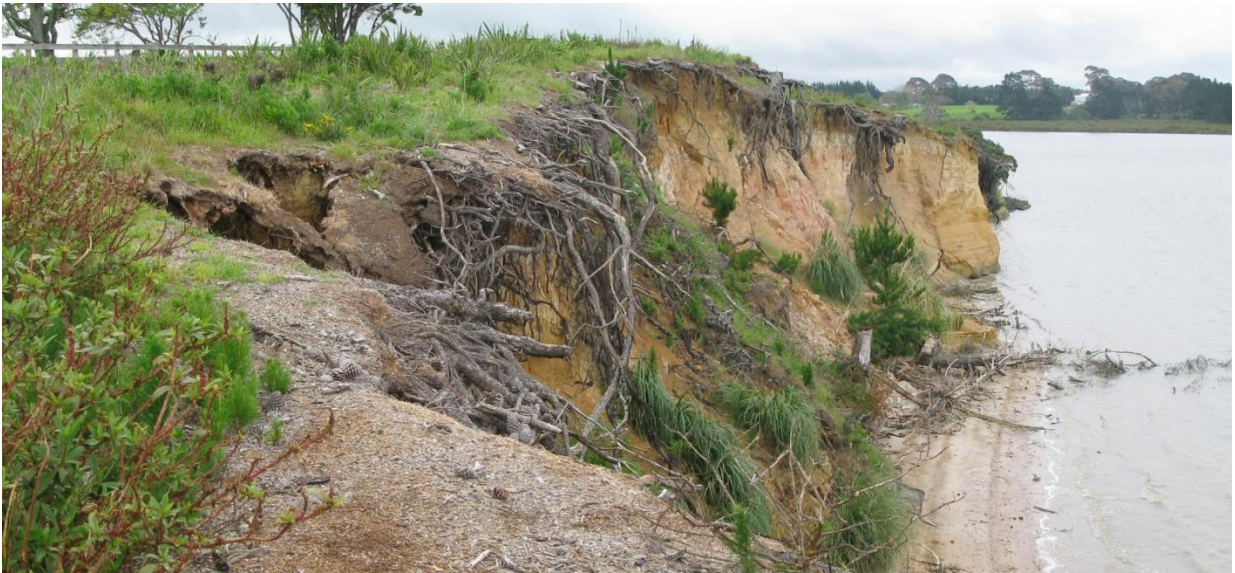
Figure 1: Views of steep eroding cliffs towards western end of the exposed north-western shoreline.

14. An example of high rates of erosion occurs towards the western end, where active cliffs up to 8-10 m high occur (shown in **Figure 1** – I have also arrowed the centre of the area in the 1939, 1960 and 2011 aerial photography in **Appendix A**). In this area, the 1939 aerial photograph shows grazed pasture extending to a fence-line variously located 1-5 m from the top edge of the cliffs and 6-12 m (most commonly 6-8 m) from the shoreline. By 1960, a dense line of pine trees had been established along the top edge of the cliff. These pines were already a moderate size (typically 10-14 m wide), indicating they were probably planted at least 10-12 years earlier (i.e. prior to 1950). The seaward edge of the pine trees typically extended out over the intertidal beach seaward of the shoreline, indicating the trees were planted relatively close to the top edge of the cliff; probably close to the fence-line evident in the 1939 photo. However, despite this, these pines were mostly still standing at the time of the field inspection in May 2010 - but by this time the trunks were commonly less than 1 m from the top edge of the cliff (**Figure 2**). At least one tree had however been undermined and toppled down the bank (evident in a very clear 4 April 2009 aerial image on Google Earth – which also shows at least 2 other pine trees beginning to topple).

15. Overall, the top edge of the cliff in this area has retreated by up to 4-6 m between 1939 and the present (October 2015), indicating a time-averaged rate of cliff retreat of 0.05-0.08 m/yr (i.e. 5-8 m/century).

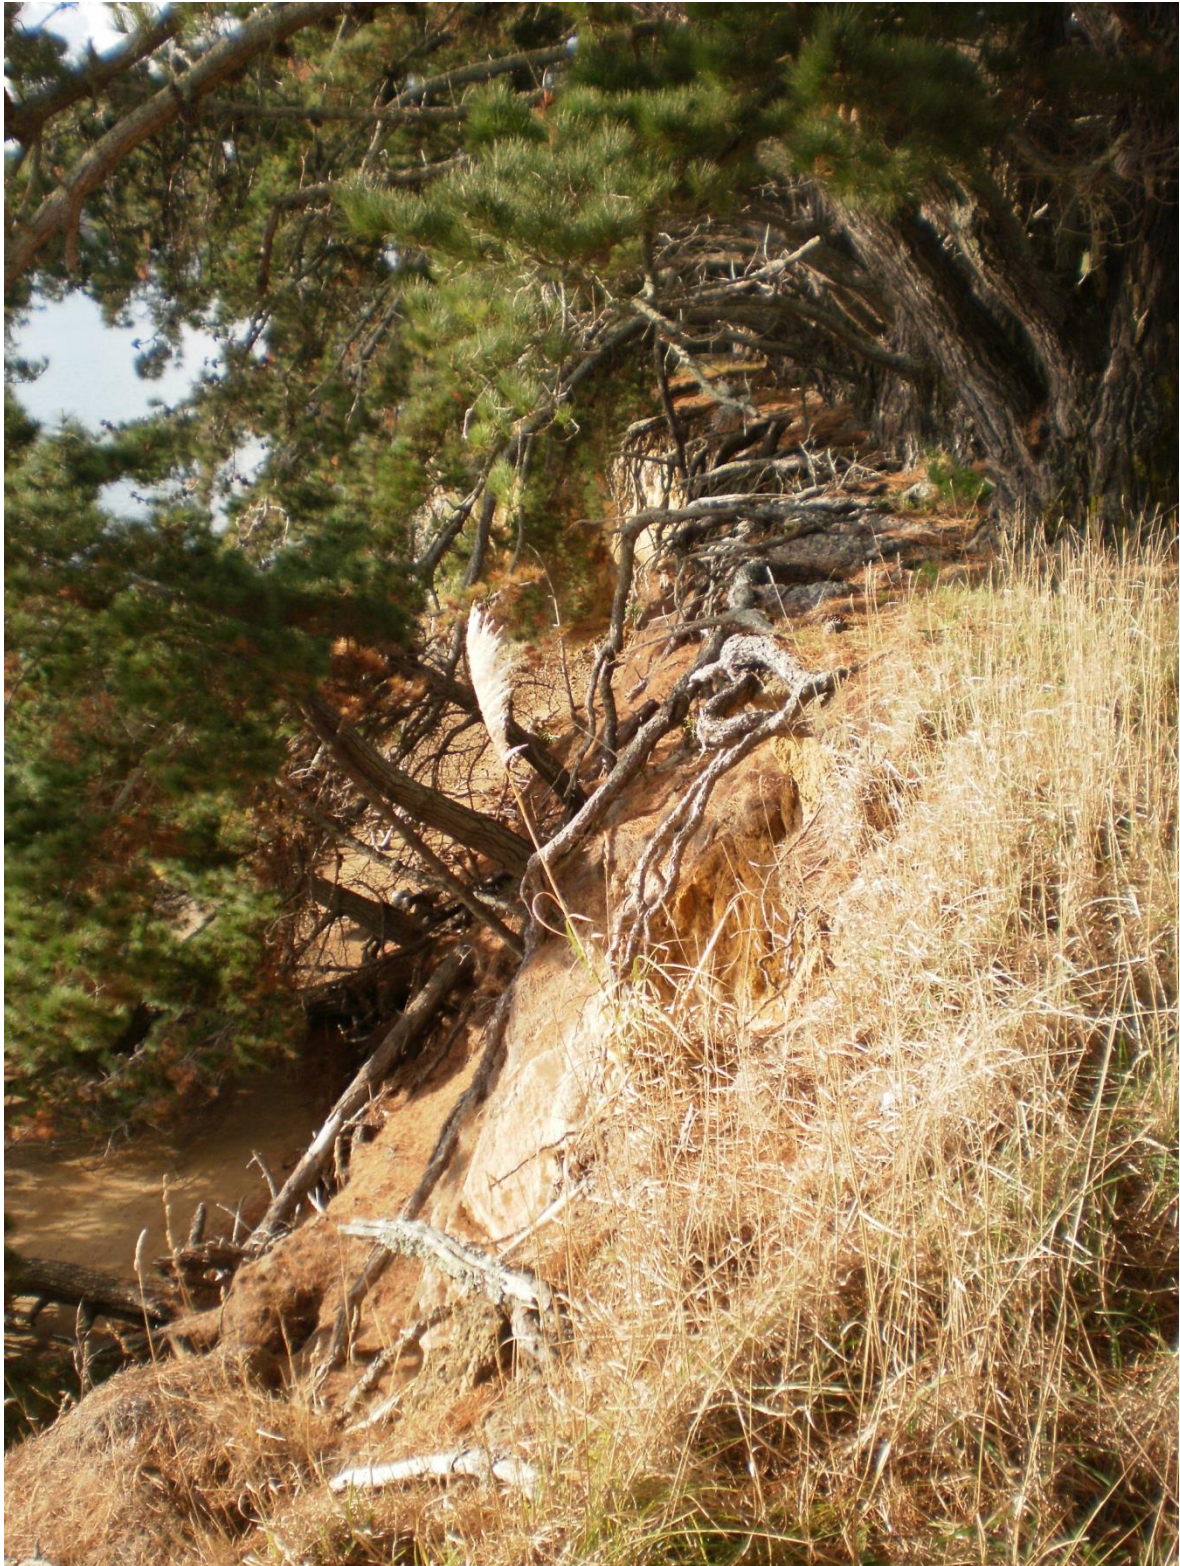
Figure 2: May 2010 view of area of northwest shoreline shown in Figure 1 – showing pine trees (planted prior to 1950) close to top edge of the cliff.

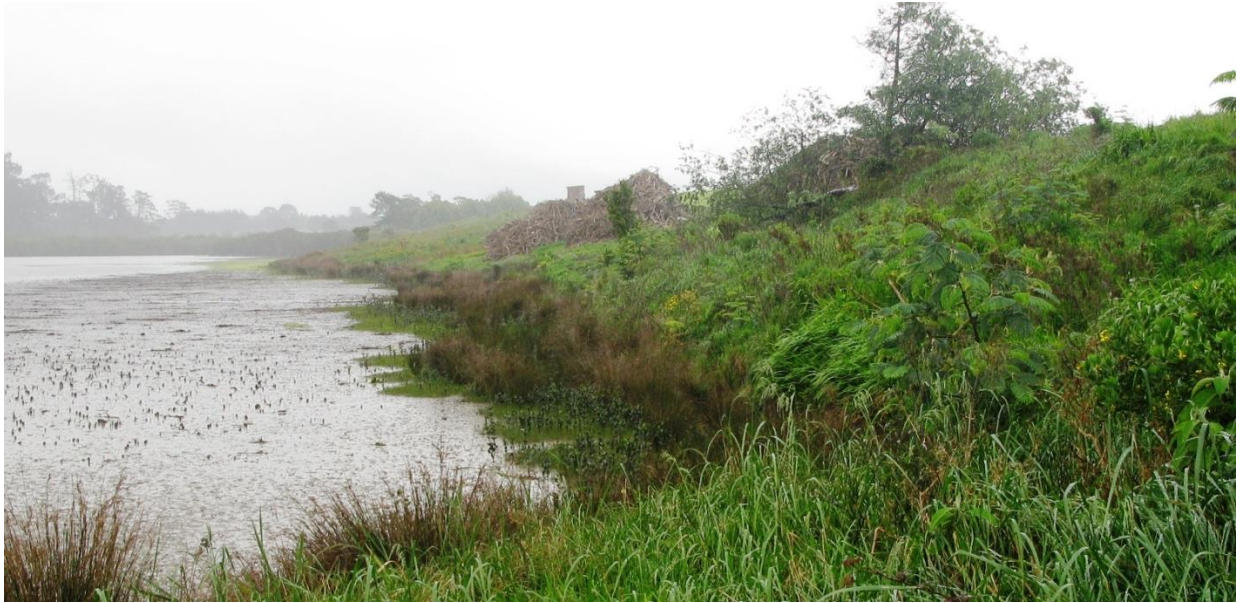
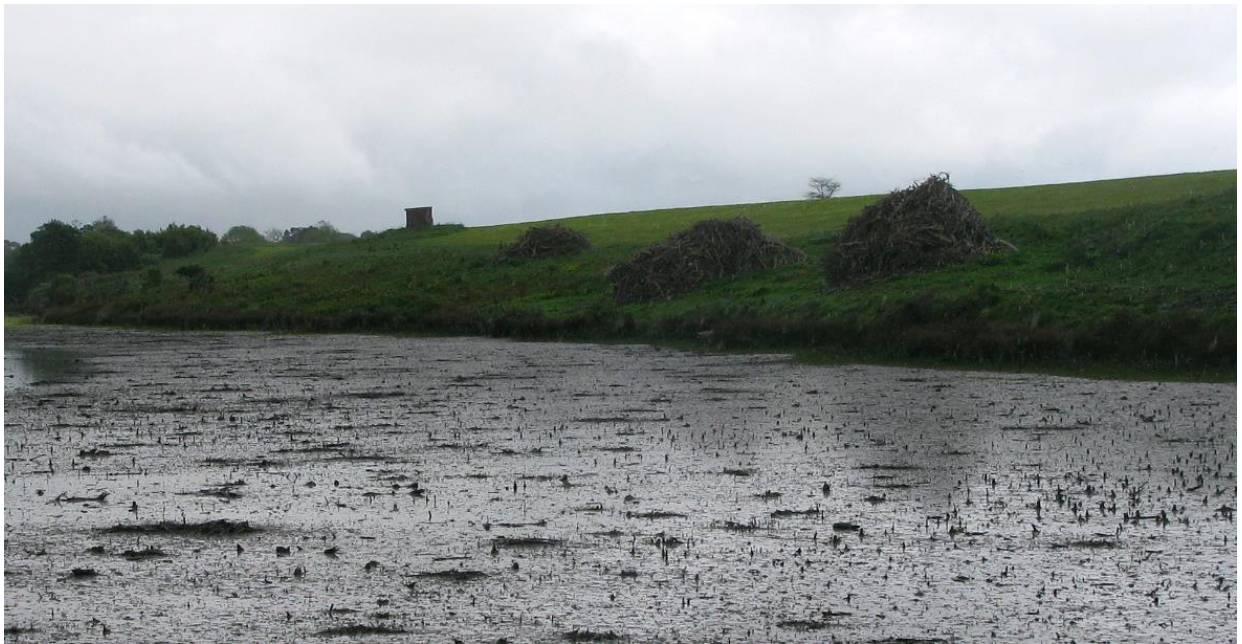
Figure 3: Views along sheltered south-eastern shoreline – viewed looking westward from eastern end.

21. This shoreline is extremely sheltered and subject to only minimal and very low wave energy.
22. Field inspection indicates no evidence of active erosion with the gently sloping shoreline commonly bordered by rushland (**Figure 3**). Until recent clearance, dense mangroves also occurred directly seaward – typically 50-100 m wide in areas east of the causeway. These mangroves were not evident in 1939 but had begun to develop by the time of the 1960 aerial photography (see Appendix A); probably in response to anthropogenic changes in sedimentation and bed levels.
23. No measurable shoreline erosion was able to be reliably discerned from the aerial photography.
24. However, a low (typically less than 0.5 m high), steep scarp does occur at the toe of the sloping bank and therefore very slow rates of erosion may occur over time.

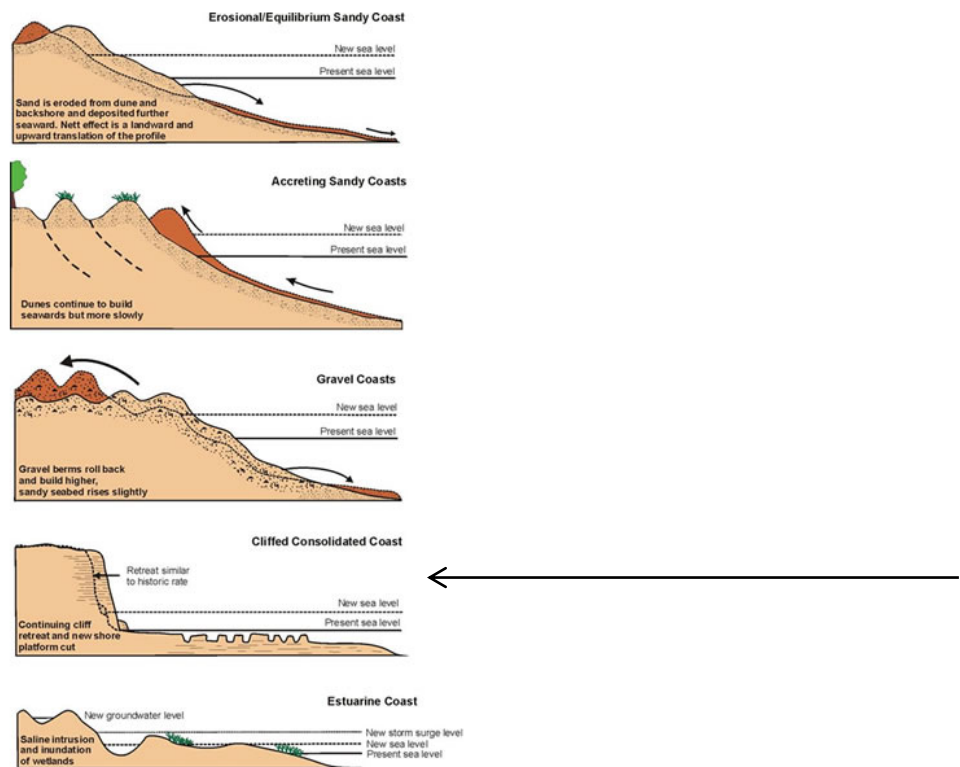
Figure 3.3: Generalised impacts of sea-level rise on different types of coastal morphology

Five diagrams showing the general response of different types of coastal morphology to sea-level rise:

- Erosional/Equilibrium sandy coasts, where sand is eroded from the dune and backshore and is deposited further seaward. The net effect is a landward and upward movement of the shore profile.
- Accreting sandy coasts, where dunes continue to build seawards, but more slowly.
- Gravel coasts, where gravel berms are rolled back causing net movement landward and upward.
- Cluffed consolidated coast, where the cliff erodes slowly landward, at similar to historic rates and new shore platform develops, and
- Estuarine coast, where rising sea and storm-surge levels cause landward saline intrusion, inundation of wetlands, and raising of the groundwater level.

Figure 4: General response of different types of coastal morphology to sea level rise (Figure 3.3 from MfE, 2008). It can be seen that on cliffed coasts (arrowed) the general expectation is that the level of toe erosion would lift with sea level rise so that ongoing cliff retreat would form a new shore platform at a higher level. However, the rate of cliff retreat is likely to be similar to historic rates.

28. The primary effect of a rise in mean sea level on cliff erosion will be to lift the focus of toe erosion a similar elevation up the face of the bank, but cliff erosion rates are not likely to be affected markedly (MfE, 2008 – see also **Figure 4**). Over long periods of time, a new shore platform will gradually develop with ongoing erosion at the higher sea level; with the shore platform formed during the period of rise likely to adopt a sloping form.
